# SERVICE BULLETIN 176E

March 3, 2003

**SUBJECT:** Necessary Actions Following Object Strike of Stationary Propeller, Blade Strike of Rotating Propeller, Bird Strike, or Sudden Engine Stoppage

**MODELS AFFECTED:** All McCauley Propellers

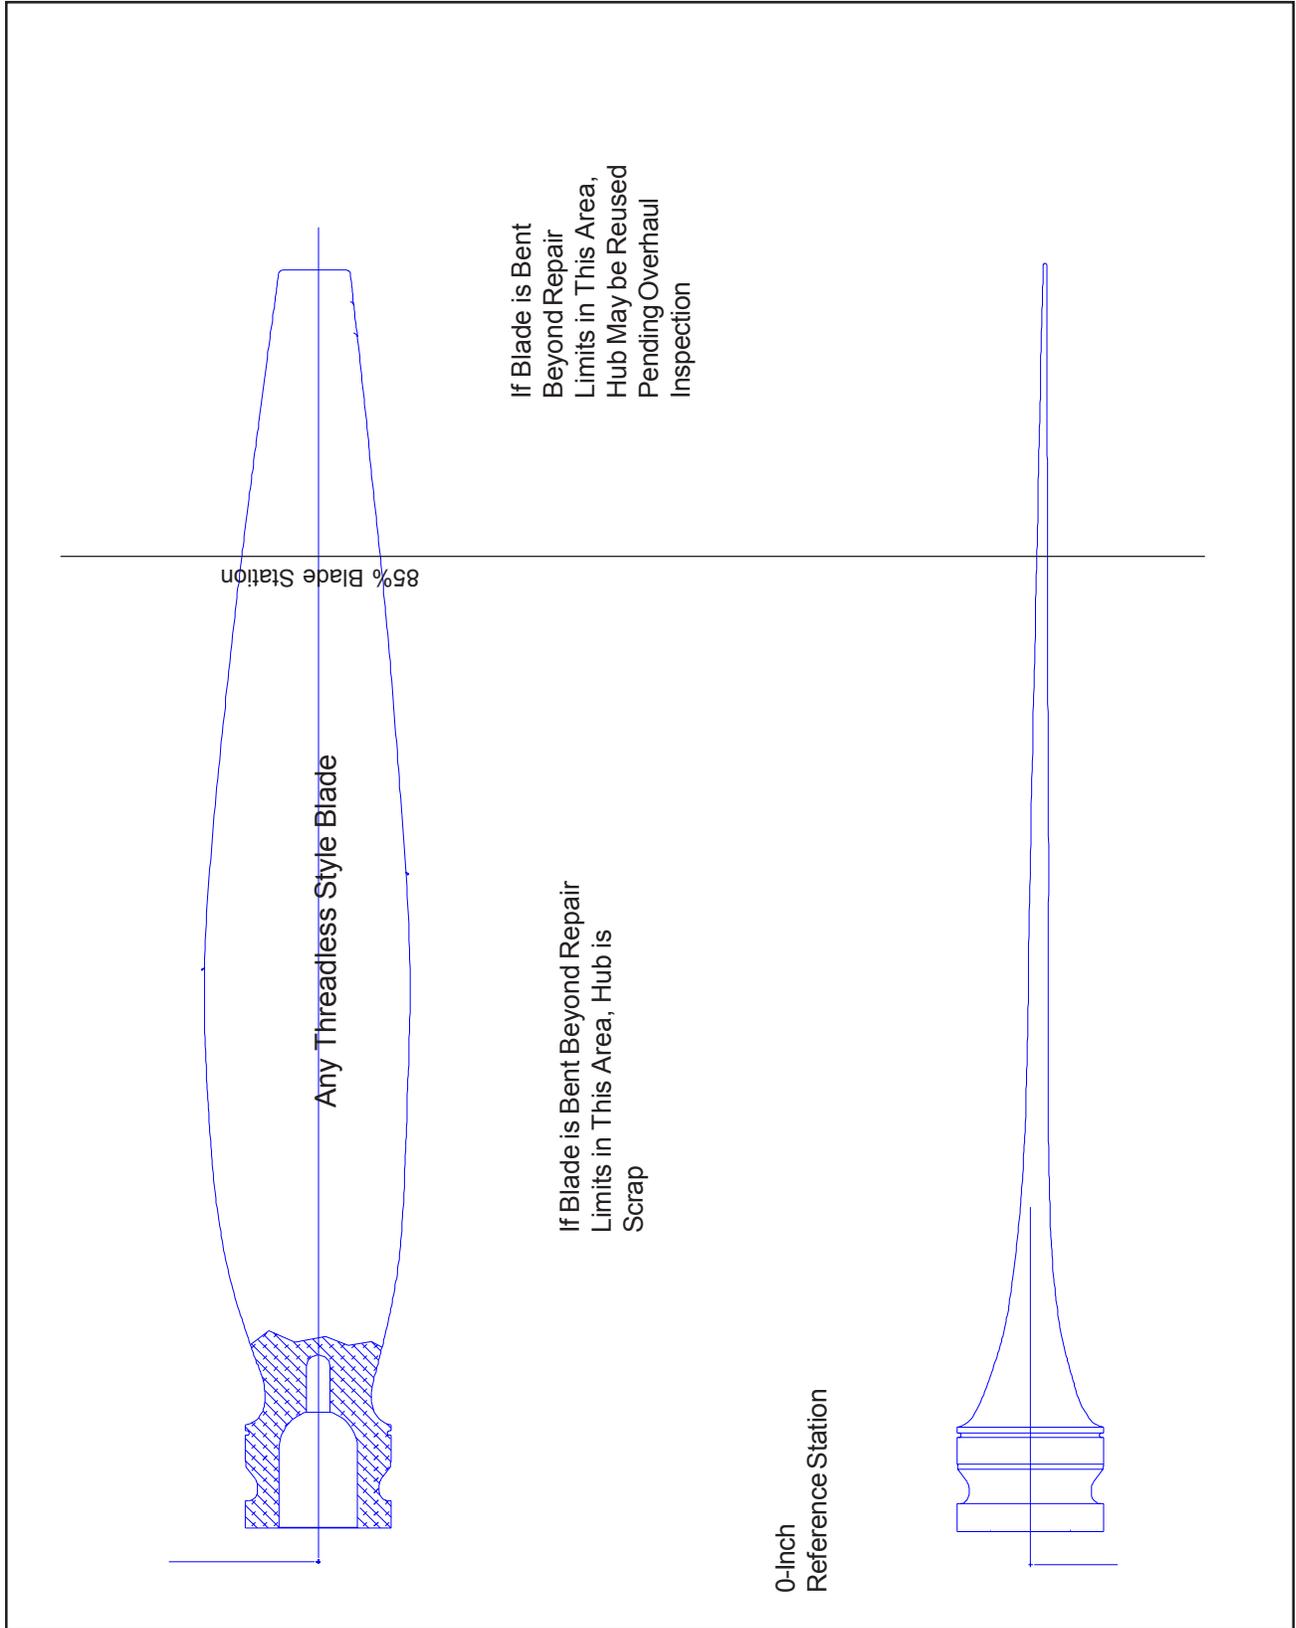
A hub must be declared unairworthy and scrapped if any blade in the propeller assembly is bent beyond repair limits within the first 85% of total blade station radius (Refer to Figure 1 and 2). A hub may be returned to service, pending normal overhaul inspection, if any blade in the propeller assembly is bent beyond repair limits outboard of the 85% blade station radius.
