SERVICE BULLETIN

SB275

C-5932 and C-5328 Feather Spring Inspection

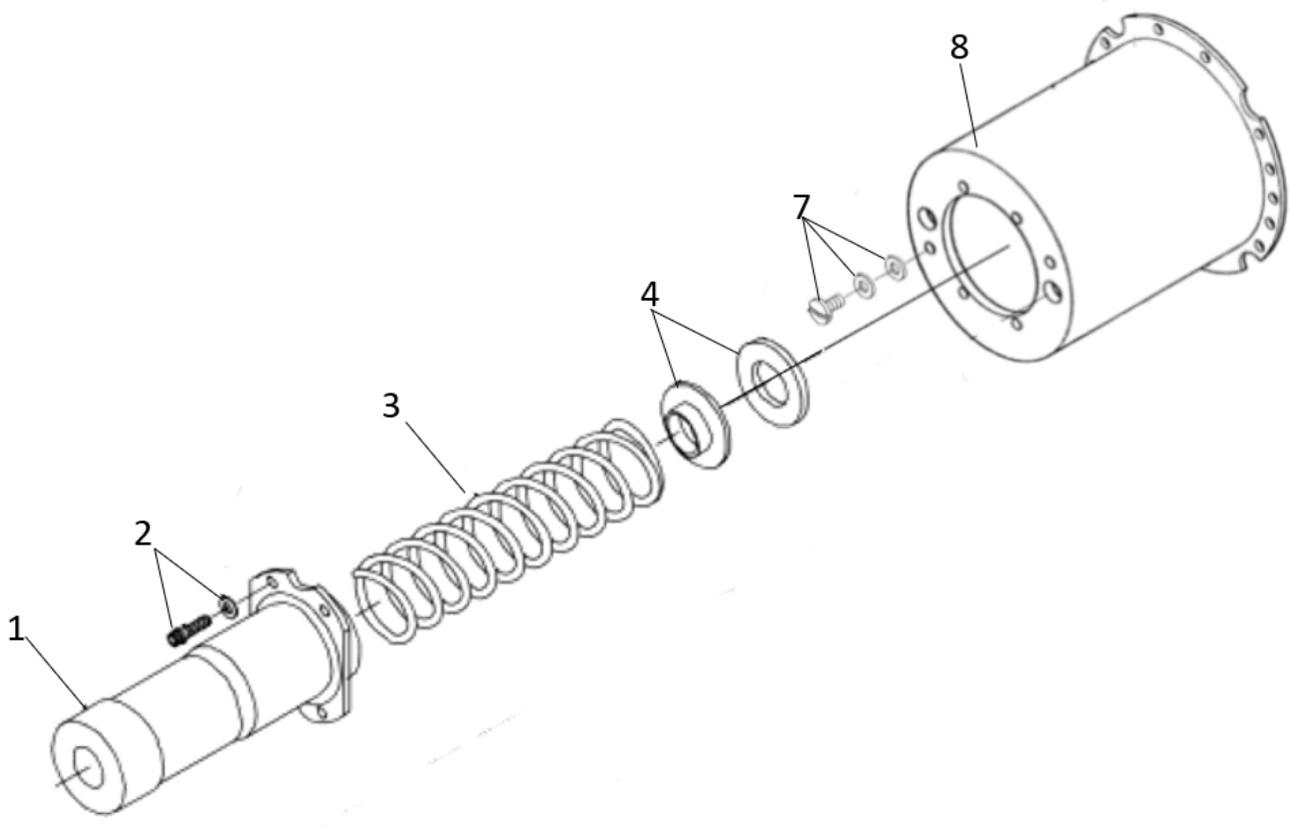
FIGURE 1
SPRING HOUSING ASSEMBLY

1. Inspection of Propeller Feather Spring
 - A. Feathering Spring Housing Removal (Refer to Figure 1 and Figure 2)

2. Feathering Spring Housing Installation Procedures (Refer to Figure 1 and Figure 2)

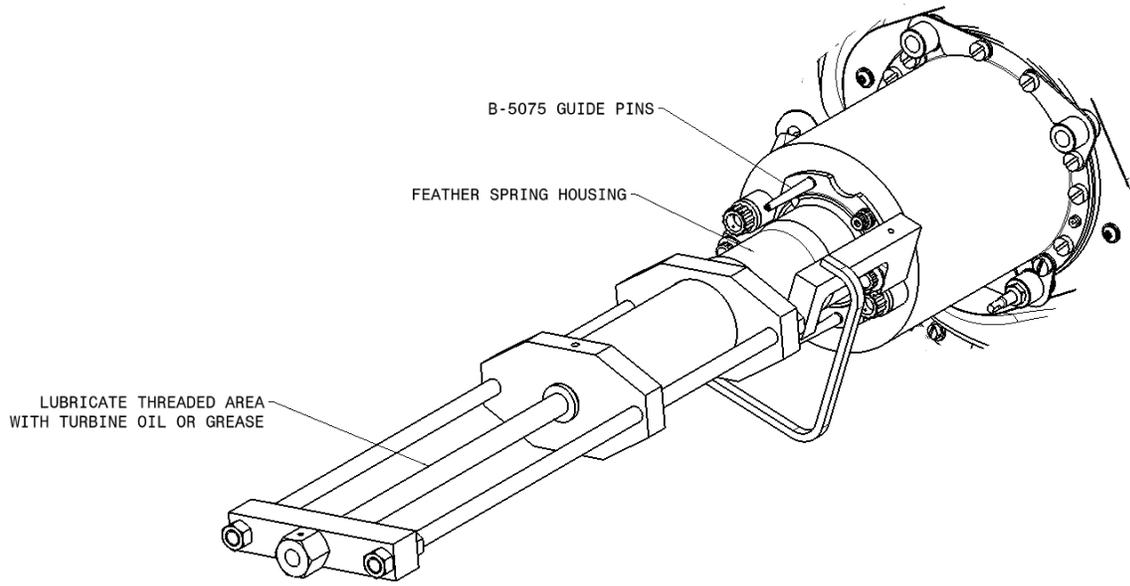
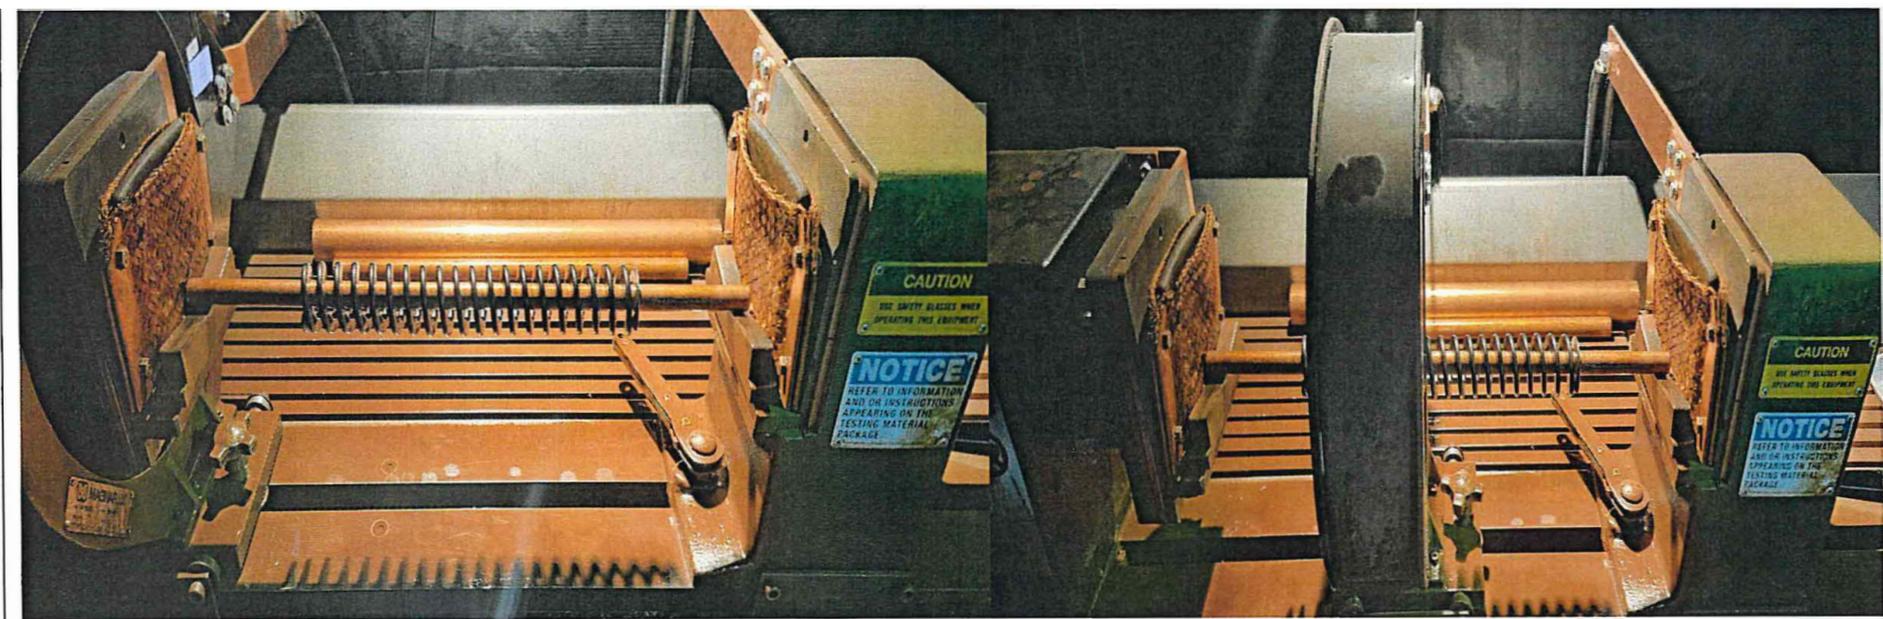
**FIGURE 2
INSPECTION TECHNIQUES**

CAUTION: THE SPRING NEEDS TO BE INSPECTED IN BOTH TRANSVERSE (ROD) AND LONGITUDINAL (RING.) REFER TO FIGURE 2 IN THIS BULLETIN.

- (1) Magnetic particle inspection shall be performed on spring part numbers C-5932 and C-5328. Magnetic particle inspection shall be used to detect cracks, laps, seams, inclusions, and other discontinuities on or near the surface of the spring.
- (2) Inspection must be performed in accordance with standard ASTM E1444, Standard Practice for Magnetic Particle Inspection, or international equivalent.
- (3) Reject any spring with magnetic particle indications and replace with a new or serviceable spring.
