# SERVICE LETTER

SL1995-4C

FIELD INSPECTION AND REPAIR OF PROPELLER BLADES

All "Threaded" C1 through C98 Propeller Models

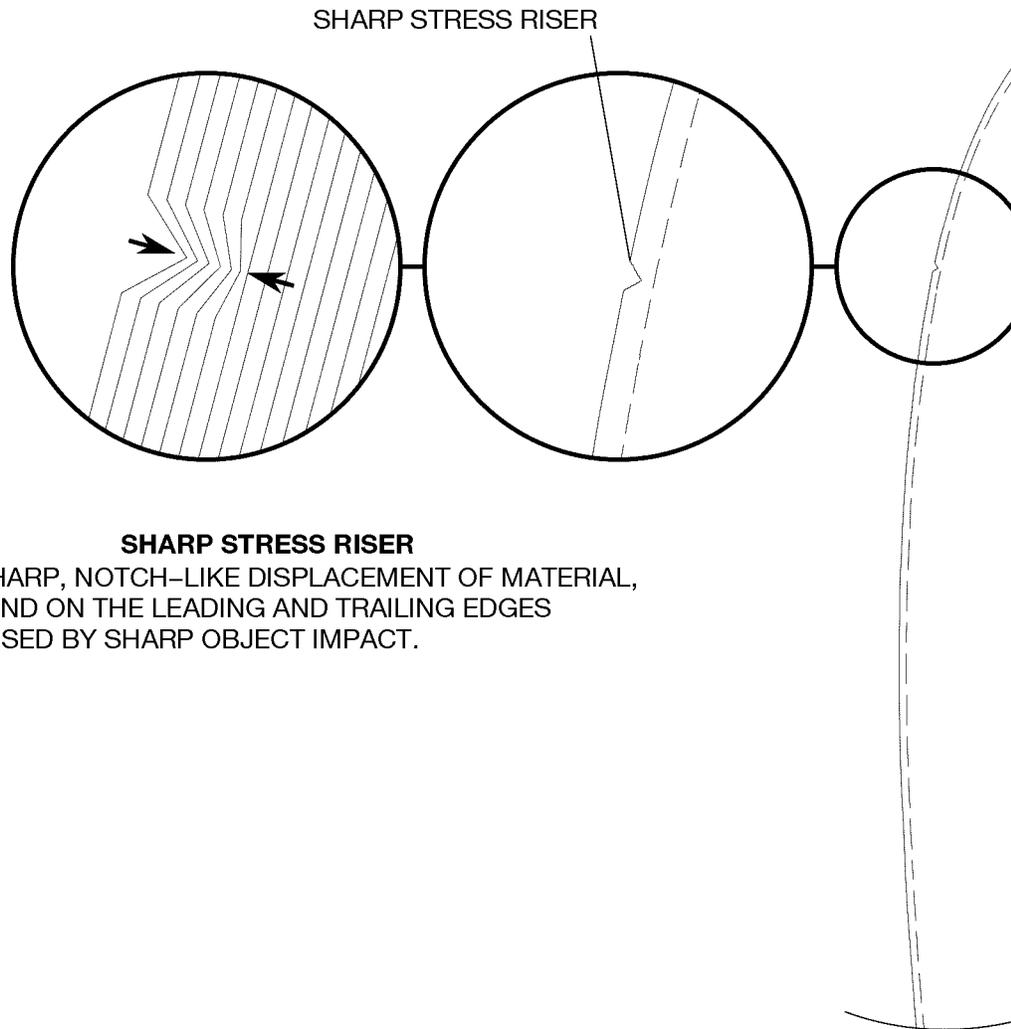
Figure 1. Sharp Stress Riser (Sheet 1)

A stress riser is an increase in stress intensity surrounding an area of reduced cross-sectional area. A sharp stress riser is an increased stress intensity attributed to a notch-like displacement of material resulting from a sharp object impact, leaving a very small radius at the bottom of the displaced material (see Figure 1).

to a notch-like displacement of material resulting from a sharp object impact, leaving a very small radius at the bottom of the displaced material, refer to Figure 1.

**SHARP STRESS RISER**

A SHARP, NOTCH-LIKE DISPLACEMENT OF MATERIAL,  
FOUND ON THE LEADING AND TRAILING EDGES  
CAUSED BY SHARP OBJECT IMPACT.
